NACA RM L50G10

RESEARCH MEMORANDUM

FLIGHT MEASUREMENTS WITH THE
DOUGLAS D-558-II (BuAero No. 37974) RESEARCH AIRPLANE

LOW-SPEED STALLING AND LIFT CHARACTERISTICS

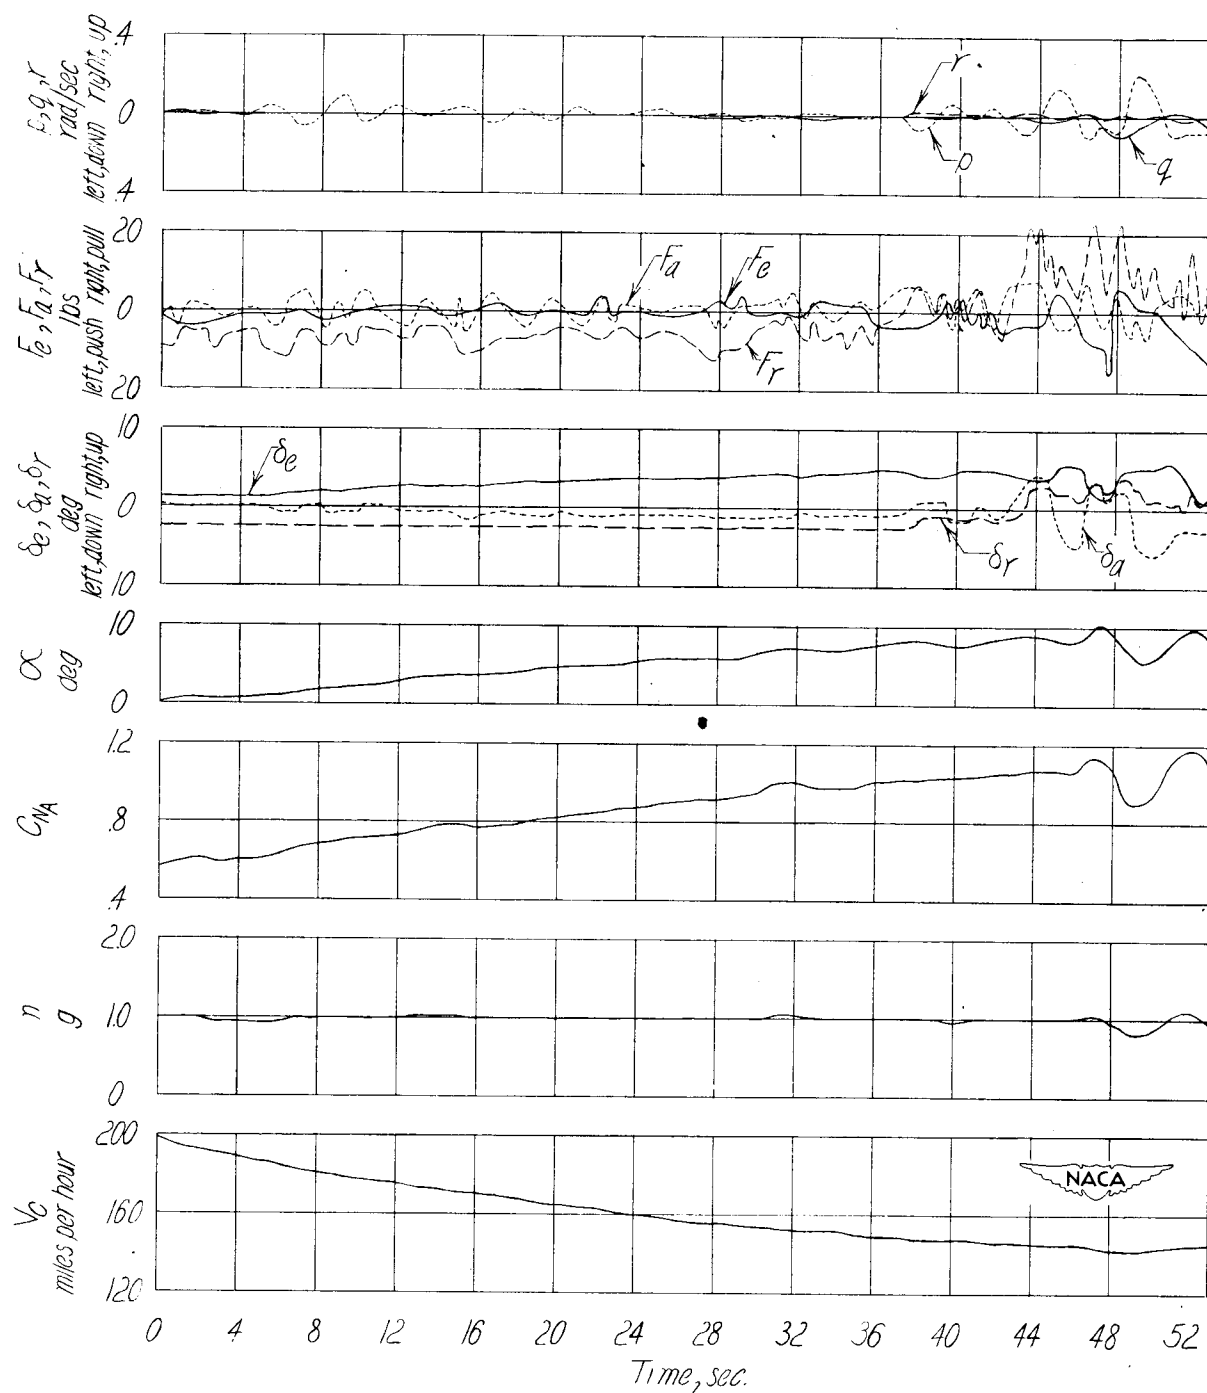
(a) Time history.

Figure 14.- Stall data for the Douglas D-558-II (BuAero No. 37974) research airplane. Flaps down; landing gear down; slats locked; inlet-duct flaps open; stabilizer setting 2.2° ; center of gravity at 26.1 percent mean aerodynamic chord.

Flaps down, landing gear down, inlet-duct flaps open, slats locked.-
Figure 14(a) presents a time history of a stall approach in this airplane configuration. The tuft pictures are presented as figure 14(b). The stall approach was started as an indicated airspeed of about 200 miles per hour and the minimum speed reached was about 142 miles per hour. As will be shown in a later time history, figure 15, considerably lower speeds and higher angles of attack have been reached in this airplane configuration in other runs, and therefore in the time history presented as figure 14(a) the airplane was not completely stalled. The tuft pictures of figure 14(b) also show that the wing of the airplane was only partially stalled at the highest angles of attack reached. A rolling oscillation of small amplitude was present throughout most of the run. The airplane was neutrally stable or slightly unstable longitudinally in the speed range from about 150 to 142 miles per hour. Inspection of the tuft pictures shows that stalling first occurred on the flaps. The tuft pictures at 47, 49, and 52 seconds show parts of the left and right wings to be alternately stalled and unstalled. The alternate stalling and unstalling of the wings appear to be associated with the rolling motion. When the airplane is rolling to the left at 47 and 52 seconds,

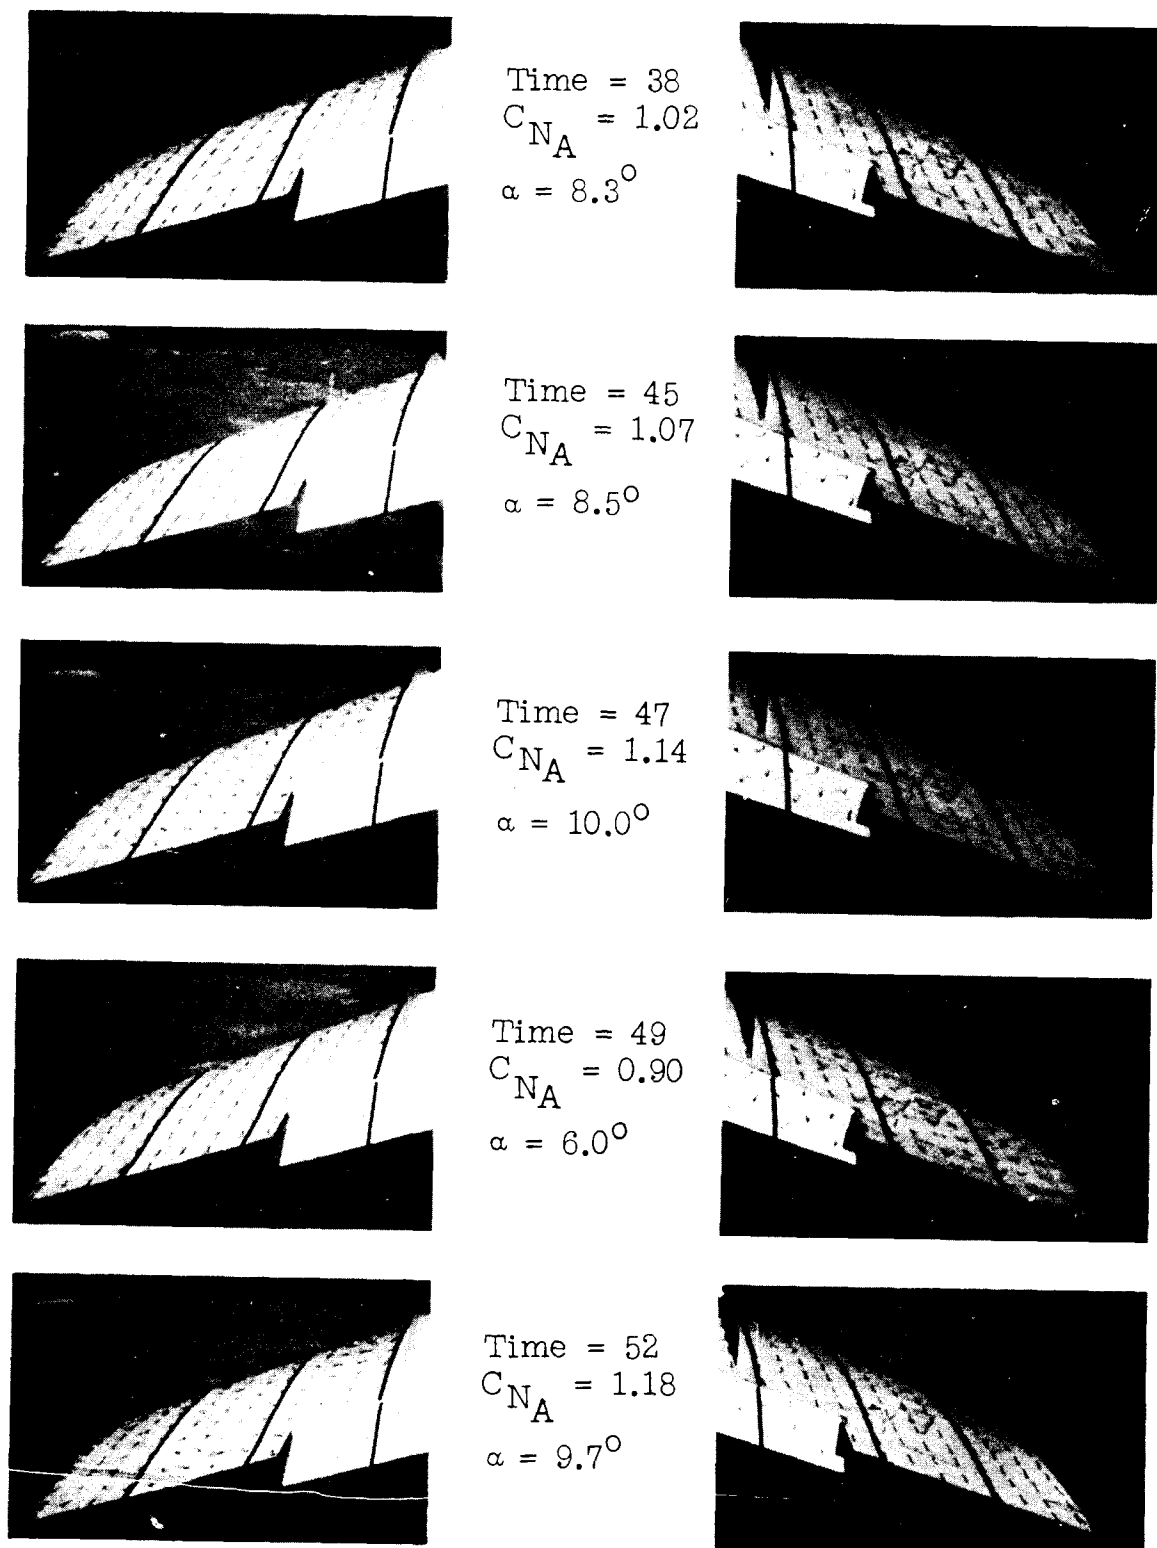
(b) Tuft pictures.

Figure 14.- Concluded.

part of the left wing is stalled; when the airplane is rolling to the right at 49 seconds, a part of the right wing is stalled.

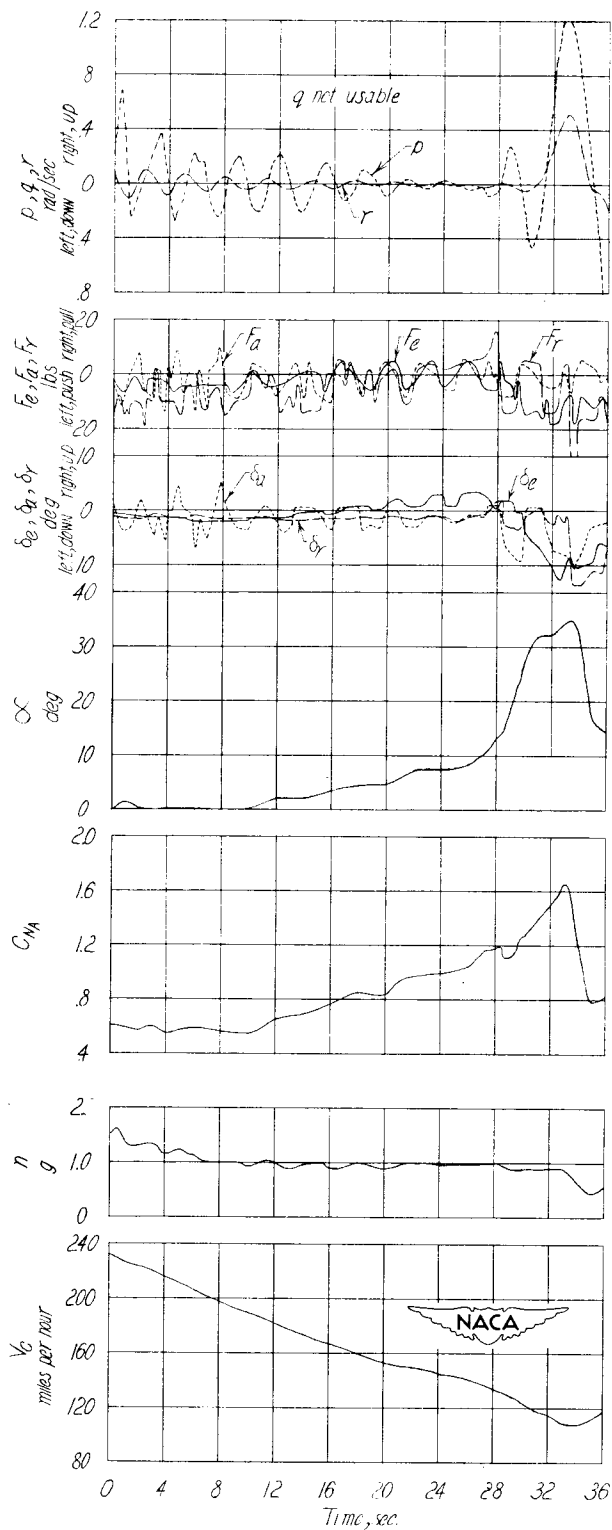
Figure 15.- Time history of a stall with the Douglas D-558-II (BuAero No. 37974) research airplane. Flaps down; landing gear down; slats locked; inlet-duct flaps open; stabilizer setting 0.7° ; center of gravity at 26.6 percent mean aerodynamic chord.

Figure 15 presents a time history of a stall approach and stall in the same airplane configuration during which much higher angles of attack were reached. The data show that at about 140 miles per hour (time 26.5 seconds) the airplane becomes very unstable longitudinally. In the time interval between 26.5 and 32.5 seconds the elevator was moved from 3.5° up to 12.5° down and during the same time the angle of attack increased from about 9° to 33° . The airplane experienced quite high rolling velocities at the higher angles of attack. A rolling velocity of about 1.2 radians per second to the right first occurred followed by a roll to the left. During the left roll the recording instruments were inadvertently turned off. After the rolling oscillation occurred the airplane went into a spin. The pilot was unable to effect recovery from the spin with the flaps and landing gear extended, but when the flaps and landing gear were retracted recovery was accomplished with the ailerons and rudder held against the spin.

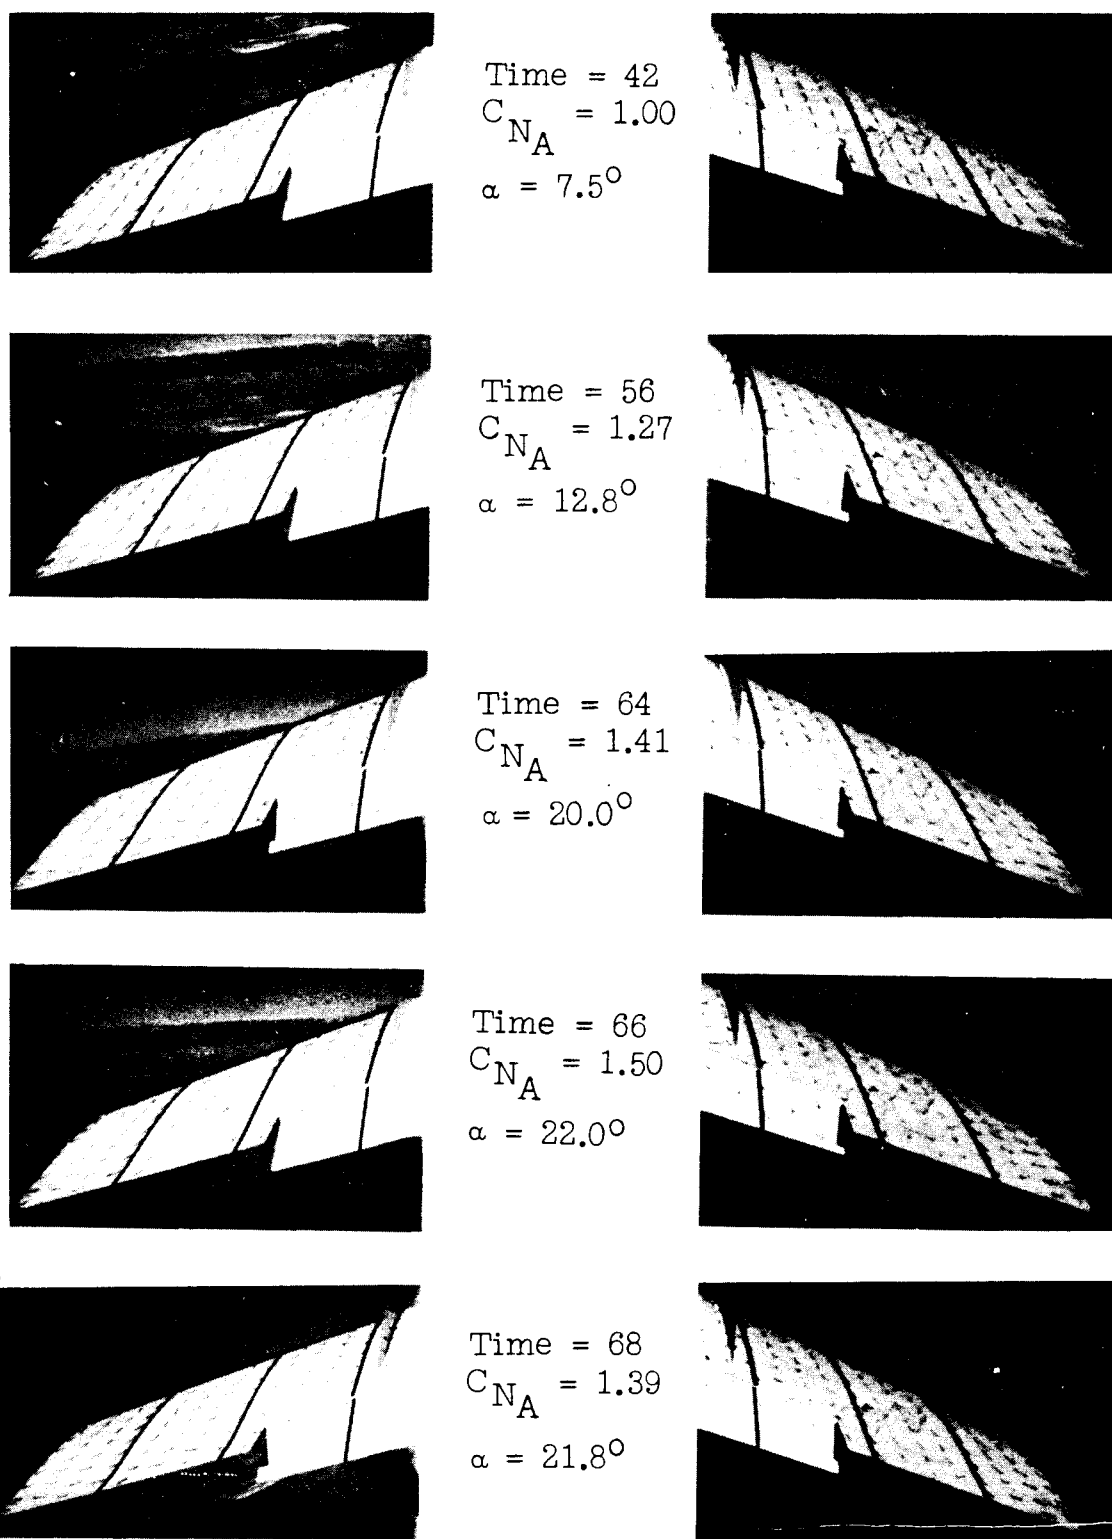
(b) Tuft pictures.

Figure 16.- Concluded.

Flaps down, landing gear down, inlet-duct flaps open, slats open.-
A time history of a stall approach in this airplane configuration is shown in figure 16(a) and the corresponding tuft pictures are presented in figure 16(b). The run was started at an indicated airspeed of 195 miles per hour and the minimum speed reached was 114 miles per hour. At the higher speeds the airplane performs a Dutch roll oscillation which damps out as the speed is decreased. This has been noted in many flights with the D-558-II airplane. With the flaps down at indicated speeds greater than about 190 miles per hour the pilots have not been able to make precision maneuvers with the airplane because of the poor damping of the Dutch roll oscillations; at speeds between about 150 and 190 miles per hour, the Dutch roll characteristics have not been nearly as troublesome.

Figure 16(b) shows that stalling first occurs on the flaps as was also the case with the slats locked (fig. 14(b)). As the angle of attack increases the slats appear to be quite effective in preventing separation as most of the stalling occurs over the inboard 50 percent of the exposed wing semispan. There is considerable outflow over the outer portions of the wing but the flow does not appear to be separated as it is inboard.

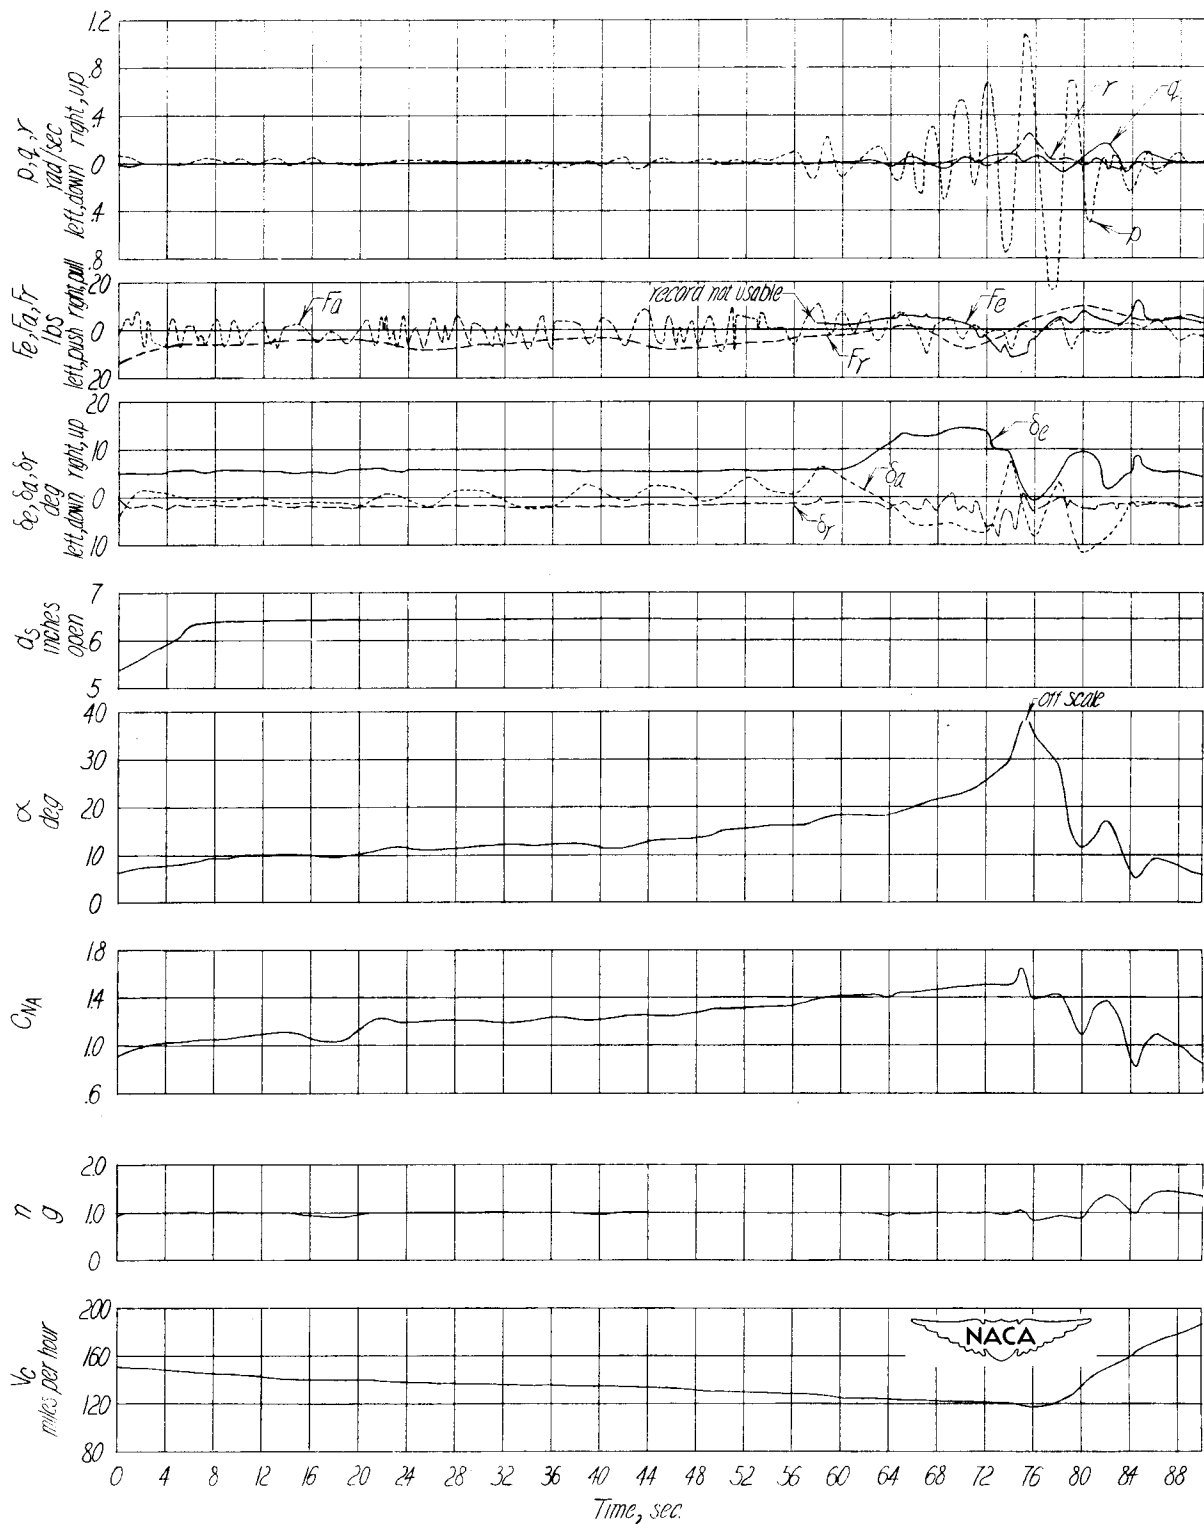
Figure 17.- Time history of a stall with the Douglas D-558-II (BuAero No. 37974) research airplane. Flaps down; landing gear down; slats unlocked; inlet-duct flaps open; stabilizer setting 1.72° ; center of gravity at 26.3 percent mean aerodynamic chord.

A time history of a stall in which considerably higher angles of attack were reached than in the time history presented as figure 16(a) is shown in figure 17. Inspection of figure 17 shows that the airplane is unstable at angles of attack greater than about 23° . At times between 72 and 75 seconds the elevator is moved from 13.5° up to 0.5° down but at the same time the angle of attack increases from 25.5° to 38° . A rolling and yawing motion involving rolling velocities of the order of 1 radian per second occurred at the high angles of attack. These motions were objectionable to the pilots and were more noticeable than the longitudinal instability. Recovery from the stall was accomplished by moving the elevator down.

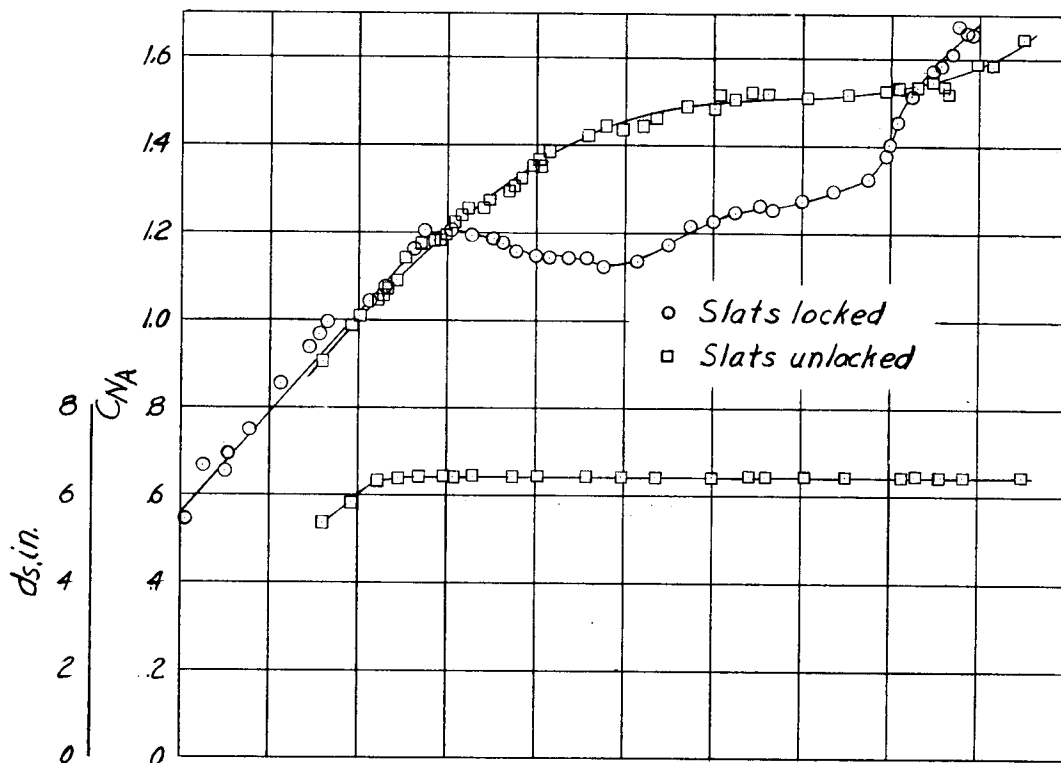
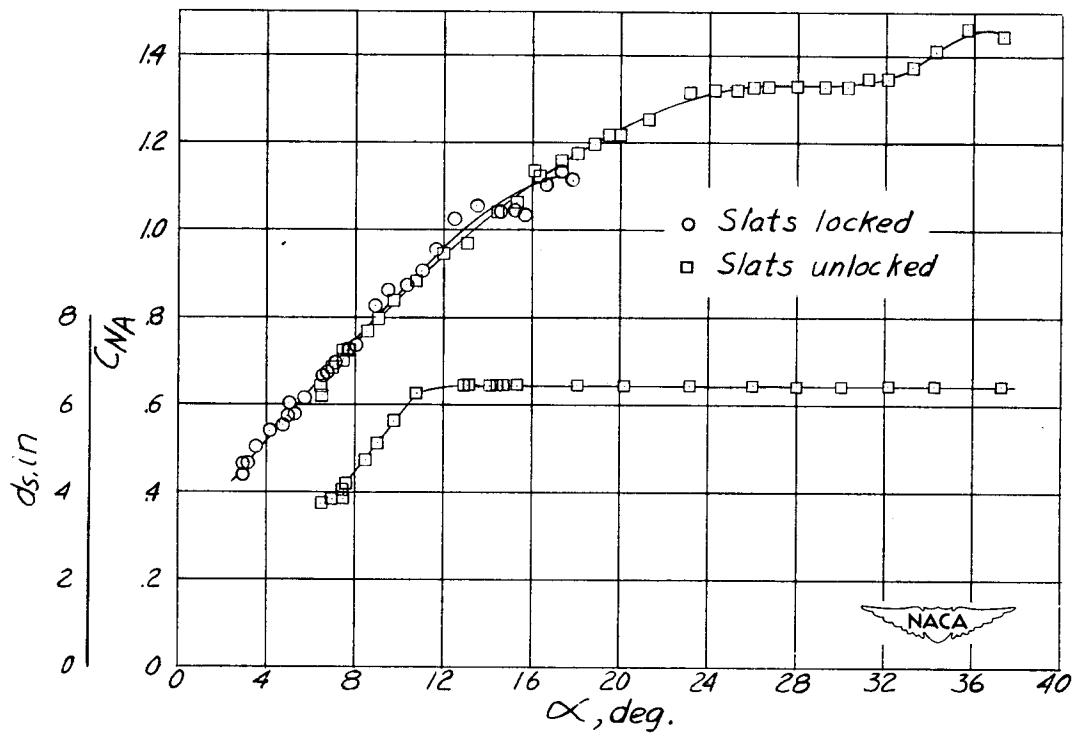
Figure 18.- Variation of airplane normal-force coefficient with angle of attack showing effect of slats.

From some of the runs previously presented as time histories of stalls, the variation of airplane normal-force coefficient with angle of attack was determined for the four different airplane configurations previously discussed. These data are presented in figures 18(a) for the flaps-up configurations and in 18(b) for the flaps-down configurations. The variation of slat position with angle of attack is also presented in figure 18.

At the lower normal-force coefficients, with the flaps up or down, unlocking the slats had no appreciable effect on the angle of attack required to produce a given normal-force coefficient. With the flaps up and the slats locked, the highest normal-force coefficient reached was about 1.13 at an angle of attack of about 18° . With the flaps up and the slats unlocked, the highest normal-force coefficient reached was

about 1.46 at an angle of attack of 36° . In the angle-of-attack range from about 23° to 30° the normal-force coefficient has a substantially constant value of 1.32. At the higher angles of attack, the lift coefficient would be considerably lower than the normal-force coefficient because of the large inclination of the normal-force vector with respect to the lift vector.

With the flaps down and the slats locked or unlocked (fig. 18(b)) the highest normal-force coefficient reached was about 1.65. This value of normal-force coefficient was reached at an angle of attack of 35.5° with the slats locked and 38° with the slats unlocked. However, in the angle-of-attack range from 12° to 32° , considerably higher normal-force coefficients can be reached at a given angle of attack with the slats unlocked than locked. For example, at an angle of attack of 25° the normal-force coefficient is about 1.5 with the slats unlocked and 1.25 with the slats locked.

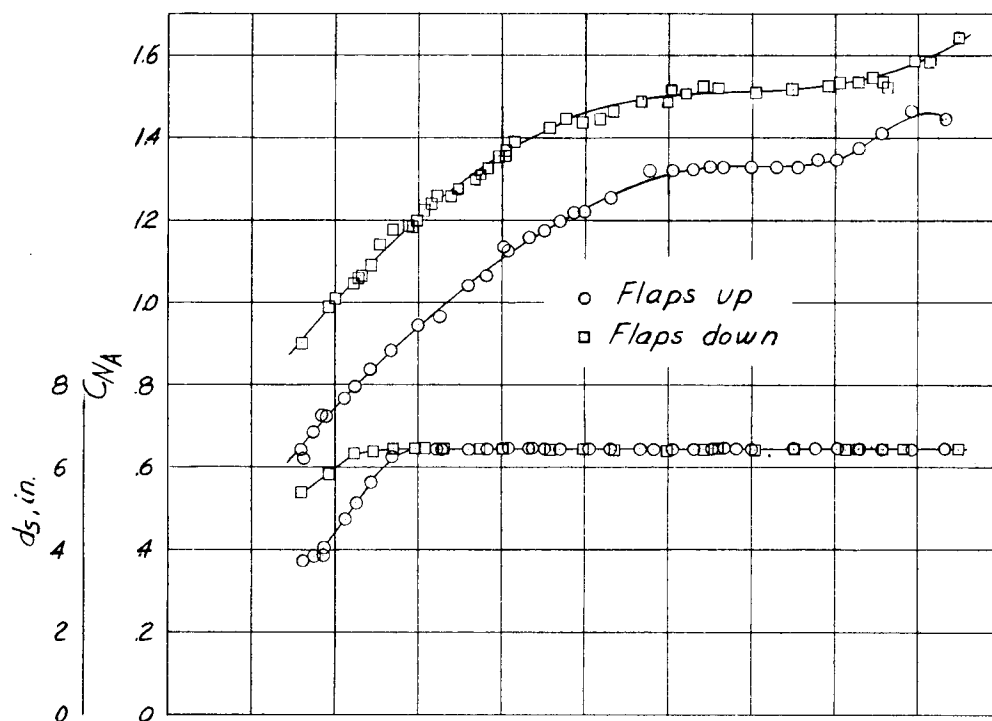
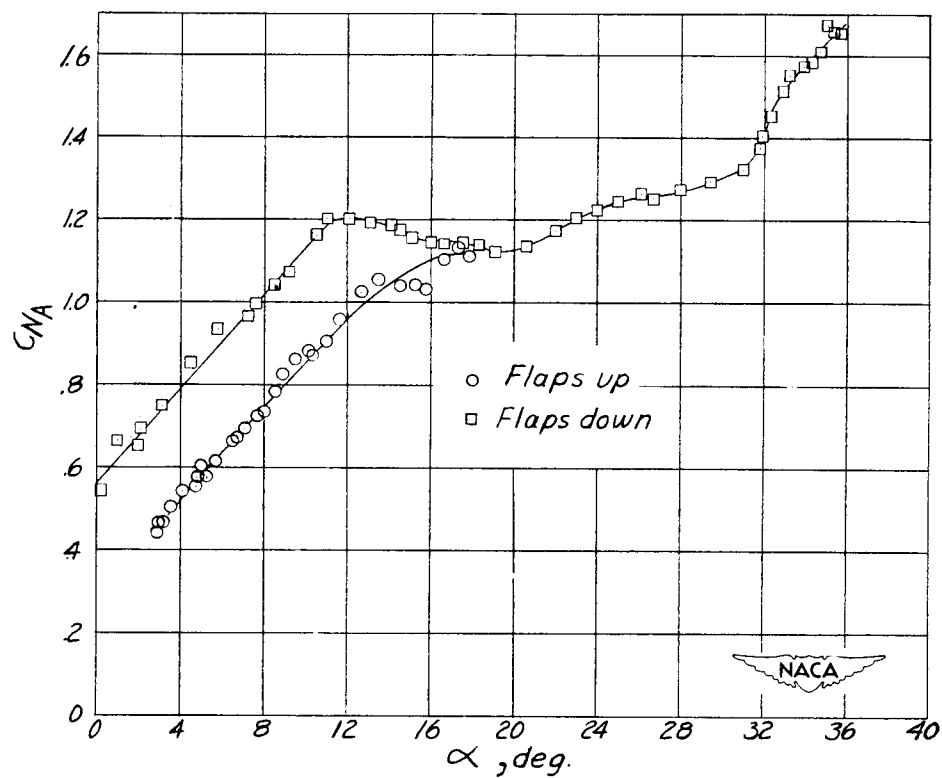
Figure 19.- Variation of airplane normal-force coefficient with angle of attack showing effect of flaps.

In order to show more clearly the effect of flap deflection on the lift characteristics the data of figure 18 have been replotted in figure 19. Figure 19(a) is for the slats-locked configuration and figure 19(b) is for the slats-unlocked configuration. At the lower angles of attack, with the slats locked or unlocked, deflecting the flaps will produce an increment in normal-force coefficient of about 0.26. With the slats locked at an angle of attack of 17° , the normal-force coefficient has approximately the same value, 1.13, with the flaps up or down. With the slats unlocked the flaps produce an appreciable increment in normal-force coefficient throughout the angle-of-attack range.
